# The first 855 “Banana Skins”

30<sup>th</sup> December 2014

This is a compendium of the “Banana Skins” originally published serially in The EMC Journal, and now published all together by Nutwood UK Ltd on their information website.

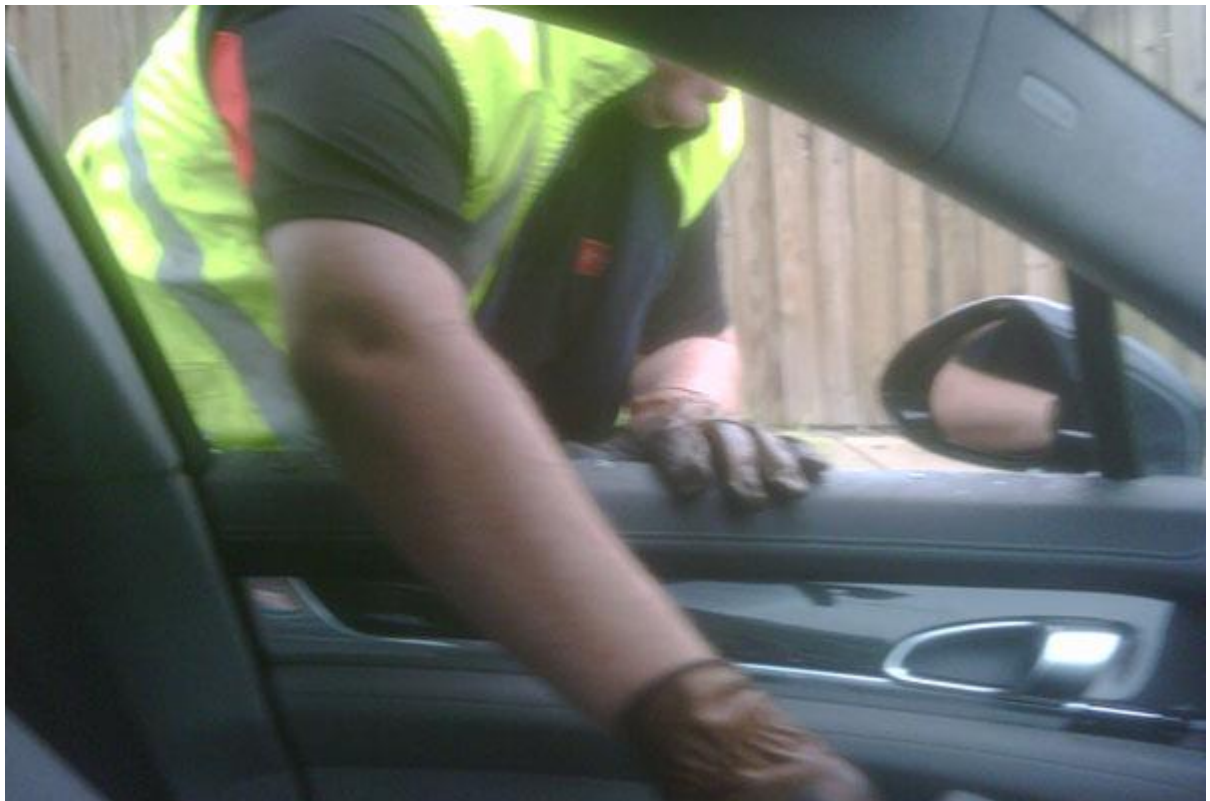
After half an hour — including a phone call to the police — the decision was made to smash a window. (See photograph below, Editor)

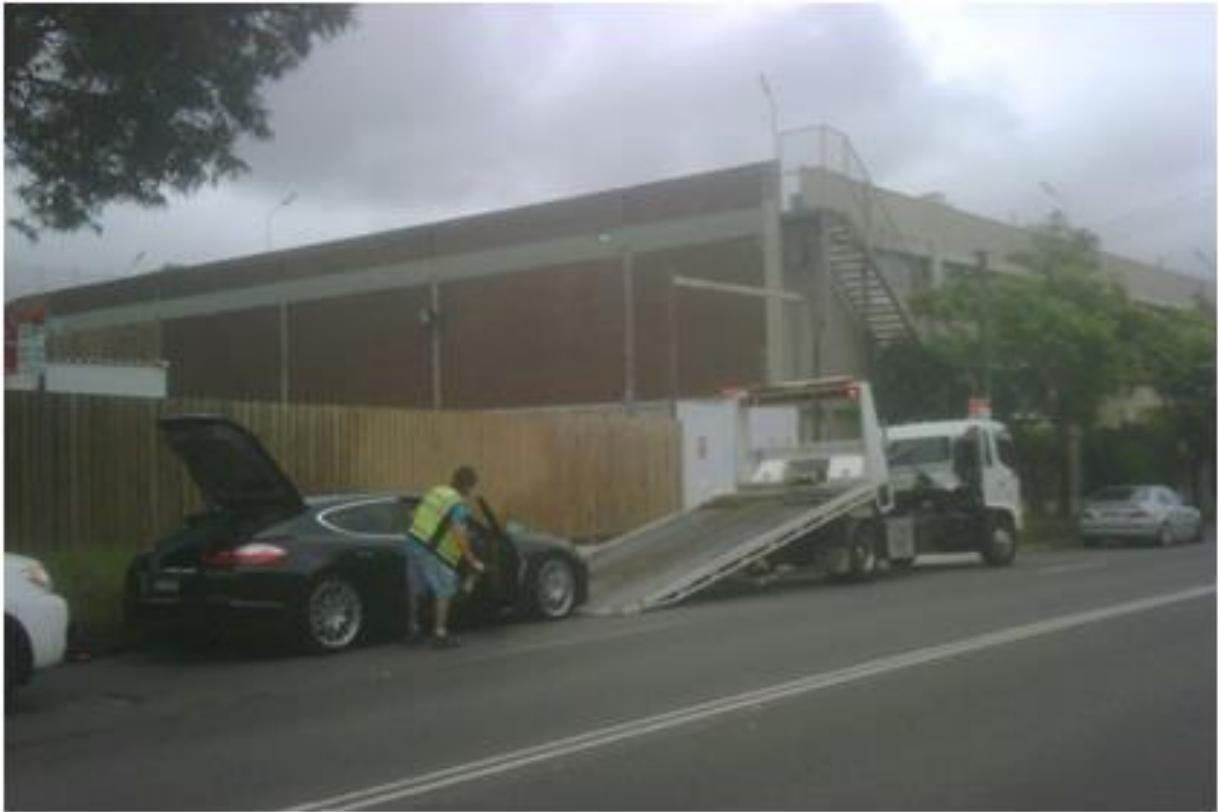
It took another 90 minutes to drag the car on the tow truck, with its electronic handbrake refusing to release. (See photograph below, Editor)

Porsche has since tracked the problem to radio interference, presumably from TV and radio towers in the area. Similar problems had apparently occurred in four other Panameras around the world, although this was the first time people were trapped in a car.

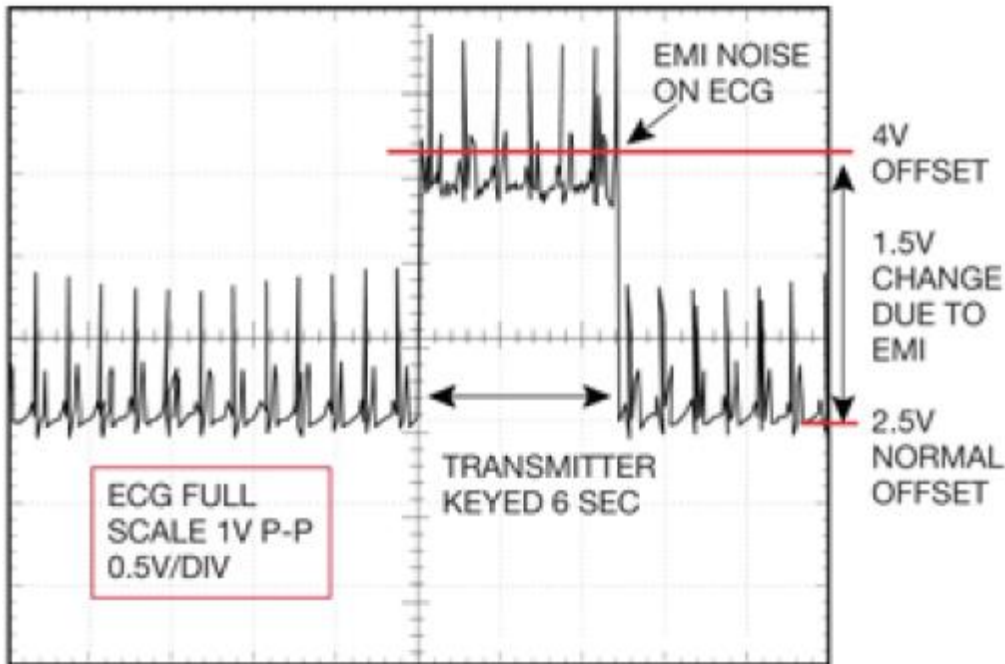
Figure 1 EMI from a cell phone can cause a 1.5V change from normal on an ECG. The ECG diagnostic tool senses a heart while a 0.5W, 470MHz transmitter turns on and off just one and a half feet away.

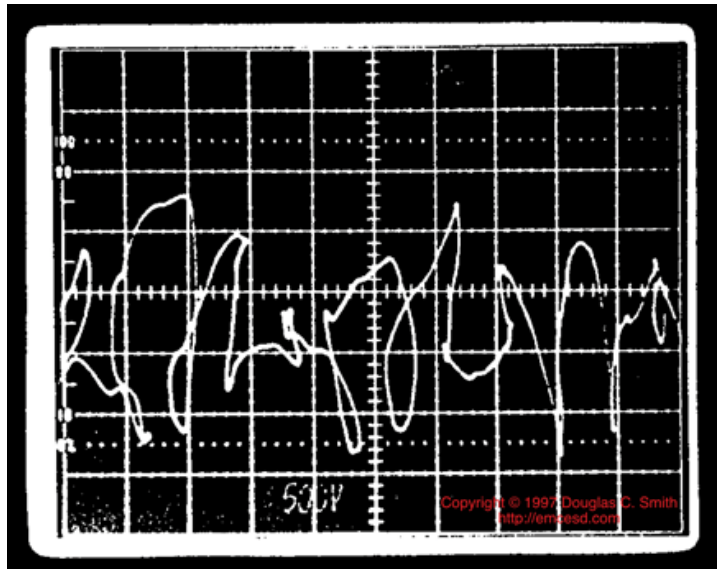
**Figure 1: Example of ESD Induced Error in an Analog Oscilloscope**

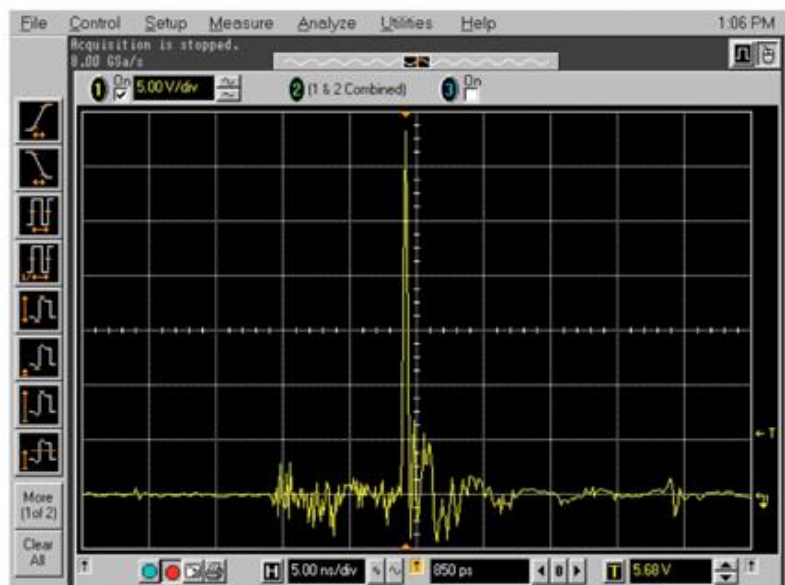
**Figure 2: Example of ESD Induced Error in a Digital Oscilloscope**

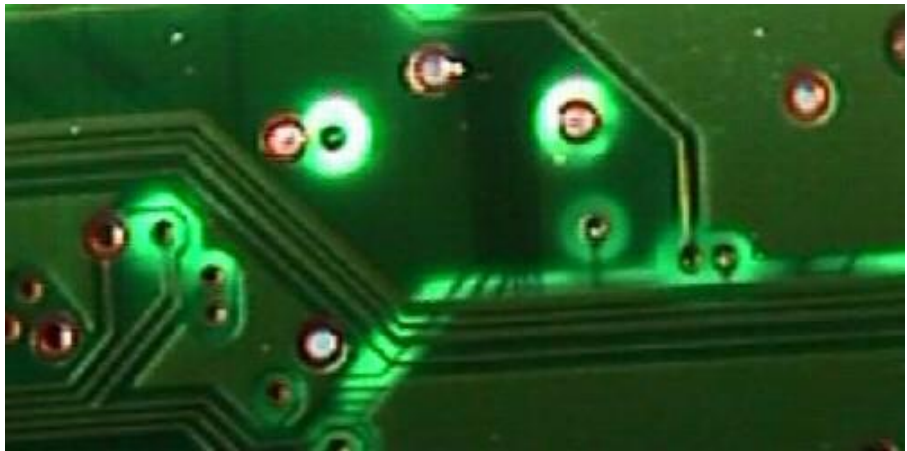
**Figure 1. Circuit board with common design flaw**

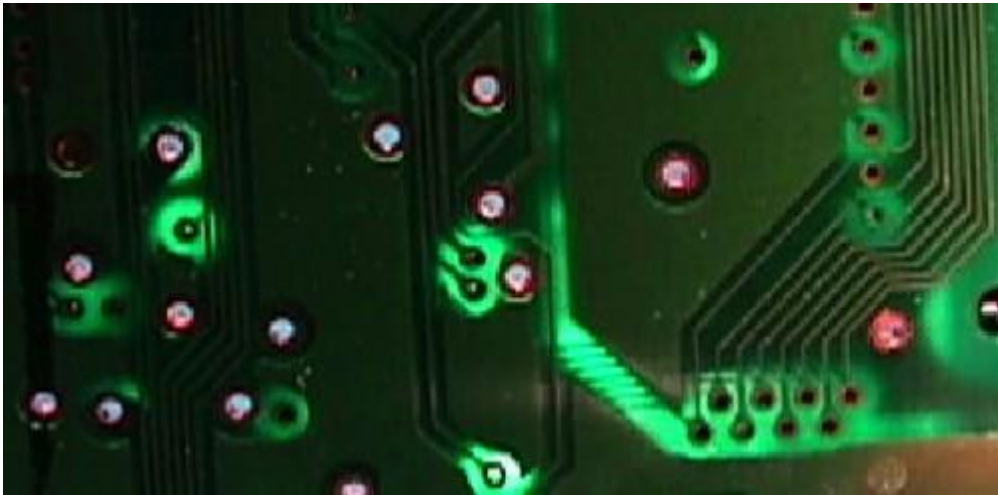
**Figure 3. Another Circuit Board Example of Signals Crossing Plane Breaks**

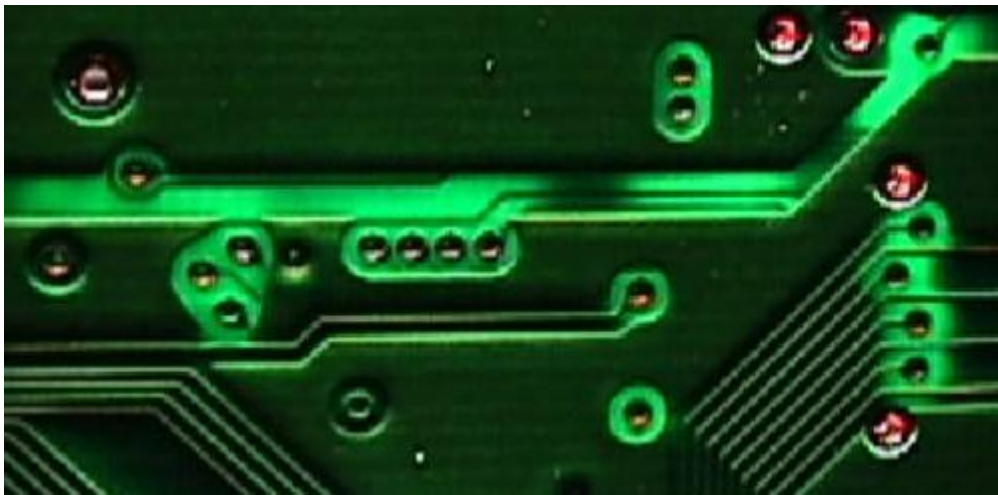
**Figure 4. Third Circuit Board Example of Signals Crossing Plane Breaks**

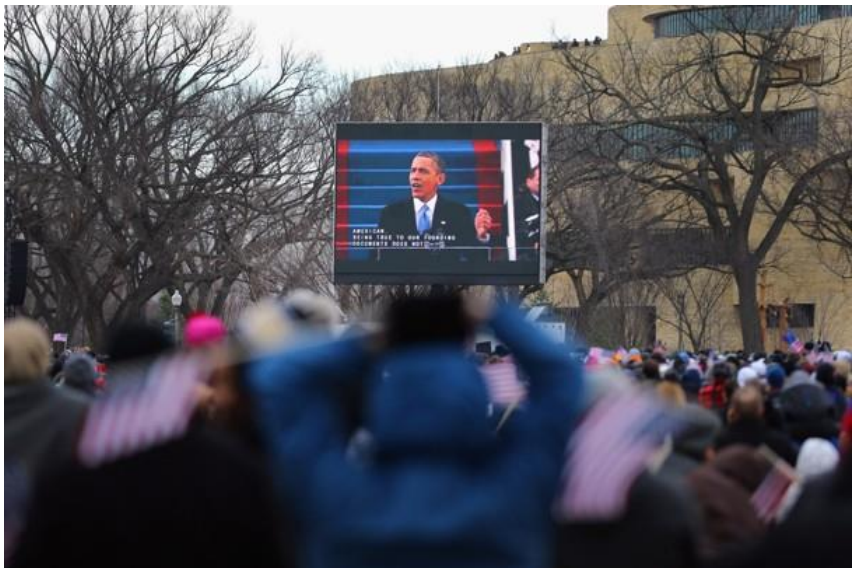
*Joe Raedle/Getty Images* – President Barack Obama is seen on a jumbotron during his public swearing in ceremony during his Inauguration on Jan. 21, 2013. Interference with a microwave signal may have caused one of the giant screens to fail.
