# The first 855 “Banana Skins”

30<sup>th</sup> December 2014

This is a compendium of the “Banana Skins” originally published serially in The EMC Journal, and now published all together by Nutwood UK Ltd on their information website.

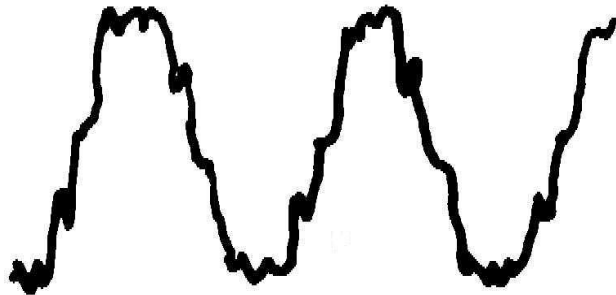
Most of these devices claim to meet the EMC Directive individually and are CE marked. However if a number of these devices are operating in one location, then their total emissions can be shown to exceed the limits for both RF and harmonics, sometimes by a large margin.

There are already instances of other equipment malfunctioning, and of sine wave distortion causing conventional transformers to overheat (due to enhanced core losses). I have experience of a building which had recently been fitted with about 50 off 50W "electronic transformers", the harmonic emissions from which so distorted the mains supply waveform that conventional transformers powered from the same mains distribution overheated.

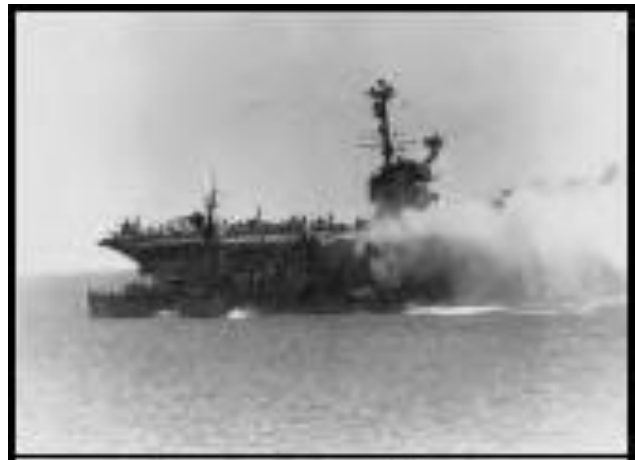
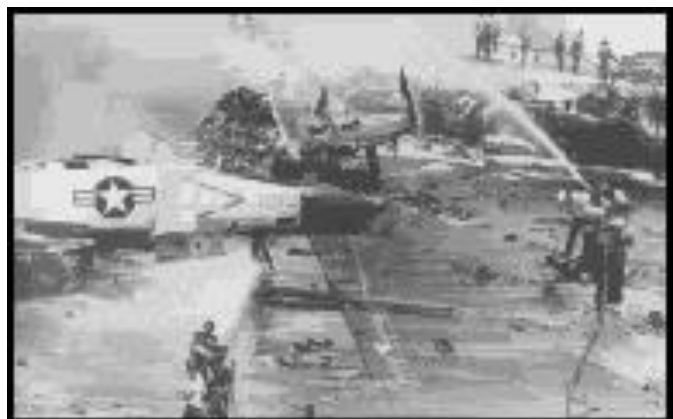
Forrestal arrived on Yankee Station on July 25 and immediately began combat operations, her aircraft flying 150 sorties during the next 4 days, without the loss of a single aircraft. At 10:52 A.M. on July 29, the second launch was being readied when a Zuni rocket accidentally fired from an F-4 Phantom parked on the starboard side of the flight deck aft of the island.

The missile streaked across the deck into a 400 gallon belly fuel tank on a parked A-4D Skyhawk. The ruptured tank spew highly flammable JP-5 fuel onto the deck which

ignited spreading flames over the flight deck under other fully loaded aircraft ready for launch. The ensuing fire caused ordinance to explode and other rockets to ignite.

The Zuni rocket that was accidentally fired from an F-4 Phantom and started the fire is believed to have been triggered by a combination of the powerful fields at deck level from the ship's radar and an incorrectly fitted shielded cable connector.

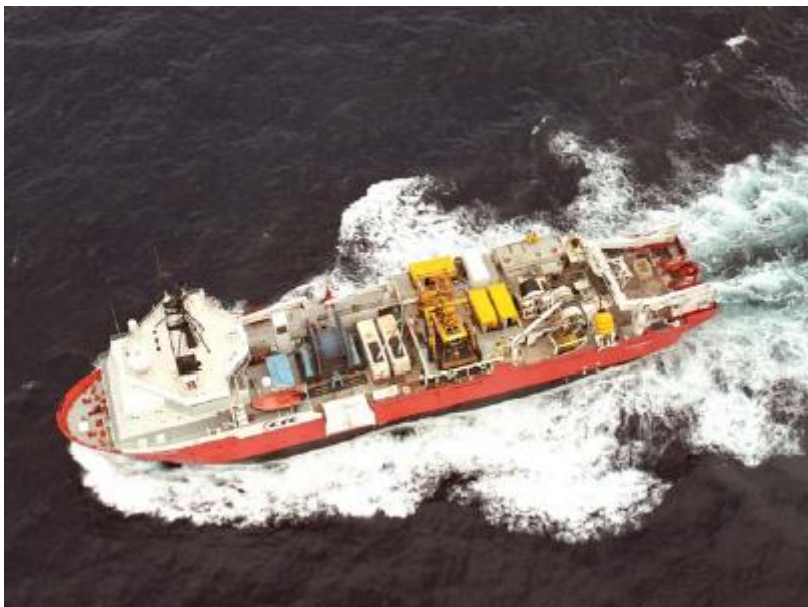
### 354) Marine mains supply harmonic distortion problems solved

The Ocean Challenger is a very high bollard pull cables ship of UT746C dual role design, equipped with a Rockplough that allows for simultaneous cable lay and burial to 1.0m depth in fractured rock, 2.2m in sand/clays and 3.0m in soft soils. The Ocean Challenger's trenching operation is performed by a 2MW Remotely Operated Pipe-line Trenching Vehicle, referred to as the ROV PT1, which is capable of operating in depths of up to 2000m. The PT1 is fitted with ten 30kW electric thrusters for manoeuvring and four 300kW Jet Sword high volume flow rate electric pumps.

The electric thrusters and pumps are independently speed controlled via AC PWM VFD's (Variable Speed Drives) mounted in the surface module. These 400V AC drives are equipped with sinus output filters and 400V to 3300V step-up transformers. From the surface module the 3300V is fed down an umbilical cable to the 3300V thrusters and pump motors. The step up in voltage is required due to the voltage drops associated with very long cable runs extending as much as 2000m.

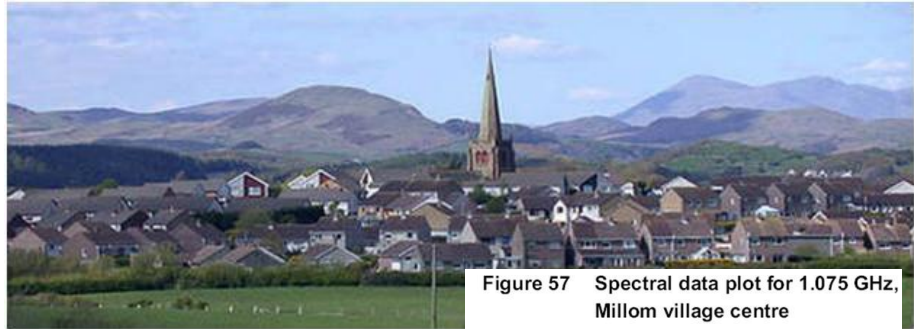
Figure 57 Spectral data plot for 1.075 GHz, Millom village centre

Another surprise was a mysterious signal at 1.075-GHz coming from the Cumbrian village of Millom.

The signal was tracked to a small shopkeeper operating an illegally imported closed circuit TV setup.

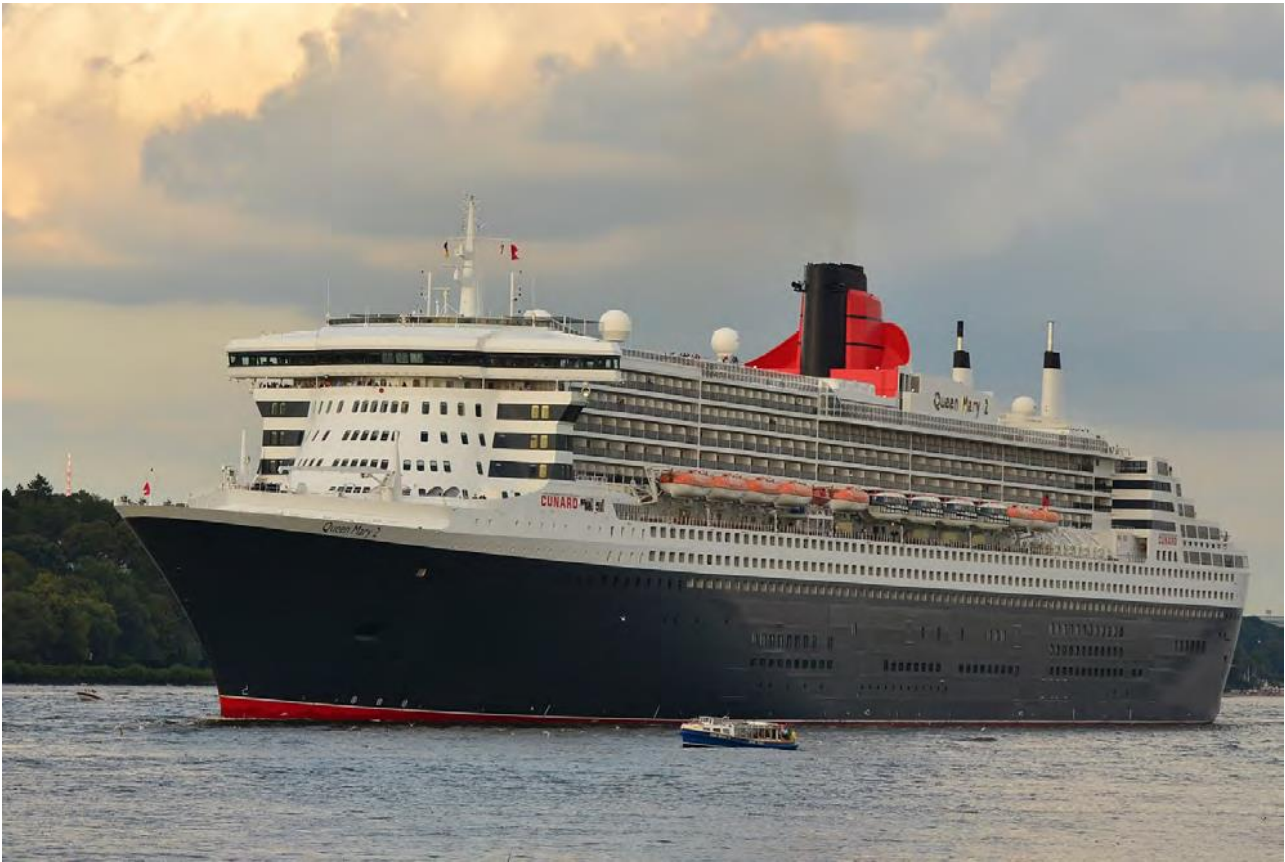
At 0425 on 23 September 2010, as RMS Queen Mary 2 (QM2) was approaching Barcelona, an explosion occurred in the vessel's aft main switchboard room. Within a few seconds, all four propulsion motors shut down, and the vessel blacked out shortly afterwards. Fortunately, the vessel was clear of navigational hazards and drifted in open sea.

The accident caused extensive damage to the aft HF and surrounding structure. Two water-mist fire suppression spray heads were activated, one in the aft harmonic filter room and the other in the aft main switchboard room.

The explosion was triggered by deterioration in the capacitors in the aft HF. Internal arcing between the capacitor plates developed, which vaporised the dielectric medium causing the internal pressure to increase, until it caused the capacitor casing to rupture. Dielectric fluid vapour sprayed out, igniting and creating the likely conditions for an arc-flash to occur between the 11000 volt bus bars that fed power to the aft HF.

A current imbalance detection system, which was the only means to warn against capacitor deterioration, was found to be inoperable, and it was evident that it had not worked for several years.

The electrical disturbance from the capacitor failure caused its circuit breaker to open and isolate the aft HF from the electrical network. It was not possible to determine the exact cause of the subsequent blackout because the option for storing historical data concerning blackouts was not chosen at build. However, it is considered most likely that the disruption within the aft HF at the time of the accident caused general instability in the electrical network which could not be contained and led to the generators shutting down.

*RMS Queen Mary 2. Photo courtesy of Jörn Prestien.*

Lloyd's Register (Europe, Middle East and Asia) (LR) has been recommended to take forward proposals to the International Association of Classification Societies to:

- Establish a requirement for all new vessels fitted with harmonic mitigation equipment to model the effect of its loss and provide data to crew so that appropriate corrective action can be taken in such circumstances.
- Require on-line or periodic monitoring of harmonic distortion of voltage on all vessels with high voltage power systems to give early warning against potential problems.
- Develop requirements to detect and mitigate against the failure of high-energy storage devices and to ensure that protection devices of critical items are fail safe.

The Maritime and Coastguard Agency has been recommended to produce specific guidance regarding the harmful effects of excessive harmonic distortion in electrical networks and to update the Code of Safe Working Practices for Merchant Seamen to raise awareness about the hazards of arc-flash in high voltage equipment.

QM2's manager, Carnival UK have also been recommended to: improve the standards of protection against the effect of harmonic distortion and component failure; and, to review the machinery alarm systems fitted to QM2 in order to identify and prioritise those alarms which indicate failure conditions that could significantly affect the safety of the vessel.

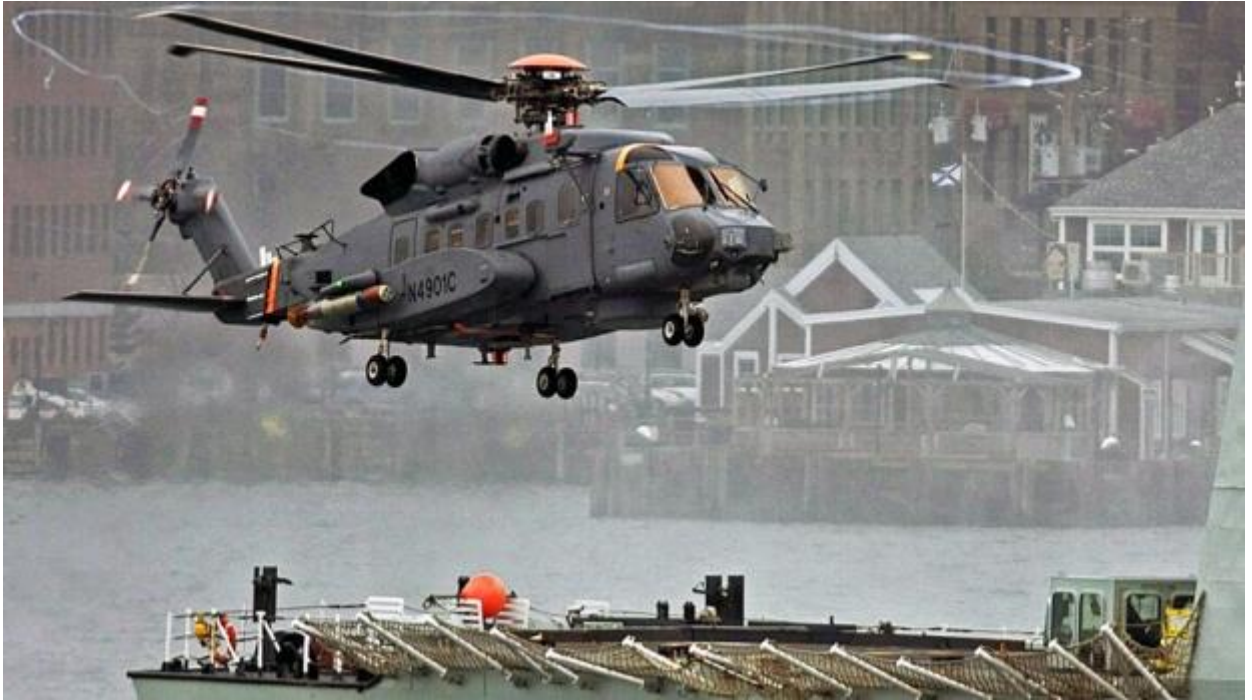
According to The Canadian Press, the Canadian government has refused to accept four CH-148 Cyclone test helicopters currently parked at the Canadian Forces facility in Shearwater, N.S., on the basis that they are "non-compliant." Designed by Sikorsky Aircraft Corporation, the twin-engine CH-148 Cyclone helicopters are slated to replace the CH-124 Sea Kings, which have been in operation since 1963.

However, the Canadian news outlet reports, defense sources with intimate knowledge of the program have elaborated on the public report, saying that certain flight systems, including a computer that runs the engines, are not considered sufficiently shielded against powerful electromagnetic waves. The electromagnetic waves could potentially scramble the digital instruments and shut down the engines.

A Canadian military Sikorsky CH-148 Cyclone conducts test flights in Halifax harbour in 2010. (Image: Andrew Vaughan/Canadian Press)

Earlier this year, the directorate of airworthiness at the Department of National Defence and the Canadian Armed Forces cited electromagnetic compatibility, electromagnetic vulnerability and electromagnetic interference concerns in its decision to impose flight restrictions on the CH-148 Cyclone helicopters.
